## DAMAGE ASSESSMENT OF SEMI-PRECAST SLABS USING IMPACT-ECHO METHOD

**Abstract.** *Semi-precast slabs are widely used in precast concrete constructions in China nowadays. However the construction quality of them are often hard to control, and the construction quality of the upper in-situ concrete of them is difficult to be guaranteed, as a result, how to detect the construction defects correctly and timely become more and more important. In this paper a traditional method Impact-Echo (IE) method is used to detect the flaws between the precast concrete and the upper in-situ concrete of the semi-precast slabs. Firstly one experimental slabs with many designed flaws was constructed, and then IE method was used to detect these flaws, finally the detected results were analysed to evaluate the proposed method. The results were processed using a mapping strategy, which indicated suspicious points where core extraction was undertaken. All cores taken from points derived from IE method results were found to have flaws providing evidence. The experimental results show that IE method may be a suitable tool to assess the construction quality of Semi-precast slabs.*

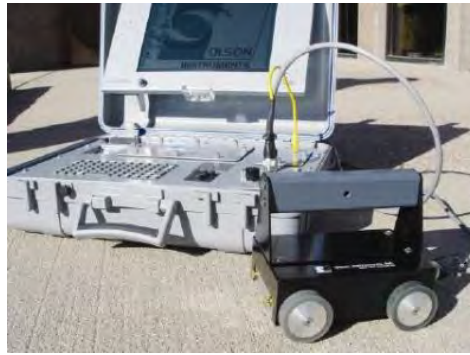
Figure 1. The view of Impact-Echo equipment.

The view of Impact-Echo equipment has been presented on Figure 1. The basic principle of the IE technique is illustrated in Figure. 2. Impact-Echo is a method for nondestructive evaluation of concrete and masonry, based on the use of impact-generated stress (sound) waves that propagate through the structure and are reflected by internal flaws and external surfaces. The standard set includes measurement heads with raisers and portable computer with special software, which is able to register the graphic stress wave aroused in investigated element as the amplitude-time and amplitude-frequency spectrum. On the other side, when in evaluated element the void does not exist, it is possible to specify the element thickness as it has been presented on the figure 2a. Otherwise, when there is a void like delaminations, then the amplitude frequency spectrum is looking like it has been shown on the figure 2b. In case of a large void the amplitude-frequency spectrum looks like on the figure 2c.

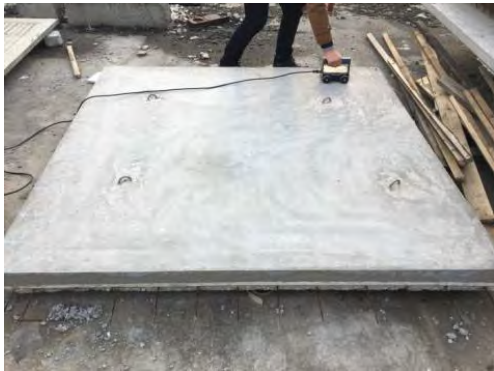
When the man-made defects installation was completed, in-situ concrete with a thickness 60mm was poured upper the precast concrete layer. The finished semi-precast slab specimen is shown in figure 4. The specimen was cured in naturalatmosphere when the in-situ concrete had been poured. When the curing is finished the in-situ measurements were conducted. The in-situ measurements photo is shown in Figure 4, the tested results were recorded, and then analysed in a computer later.

Figure 4. In-situ test photo.
