Disproportionate Collapse Mitigation in Tall Mass Timber Buildings

Hossein Daneshvar^{1*} and Ying Hei Chui²

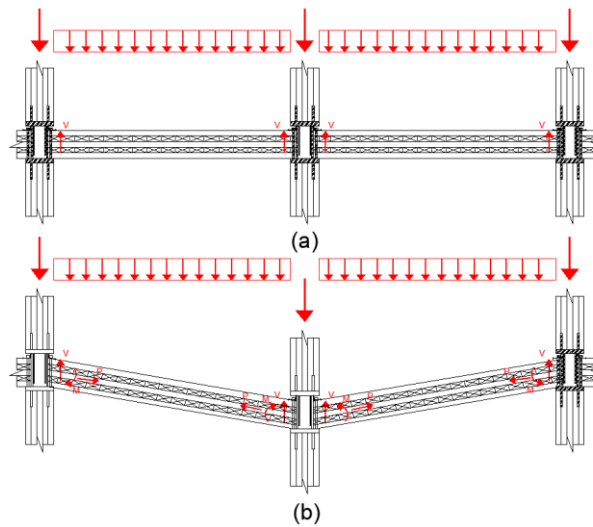
Figure 1. Column removal scenario: common case of disproportionate collapse evaluation

Disproportionate collapse is defined by a cascading progression of failure that is not proportionate to the first local damage. When a load-bearing member of a building, mainly a column or wall, is eliminated, called “column removal scenario” (CRS), due to different hazards, the internal forces in the adjacent structural components increase in order to redistribute the supported forces. If the appended internal forces caused by local damage cannot be redistributed, partial or total collapse of the building happens (Song and Sezen 2009). This phenomenon is illustrated in Figure 1. The hazards mentioned above can be natural or manmade. Terrorist attacks, accidental explosions, vehicular impact, design and construction flaws, fire, and extreme environmental loading (e.g., an earthquake) can trigger disproportionate collapse (Daneshvar 2013).

- 4- **Design for induced axial force (catenary/membrane action):** Regardless of the type of VLRS, compromising a vertical load bearing member will induce an axial force in the vicinity of the removed member. This induced tensile force, called catenary force in beams and membrane action in floors, should be accounted for in the design as shown in Figure 1.

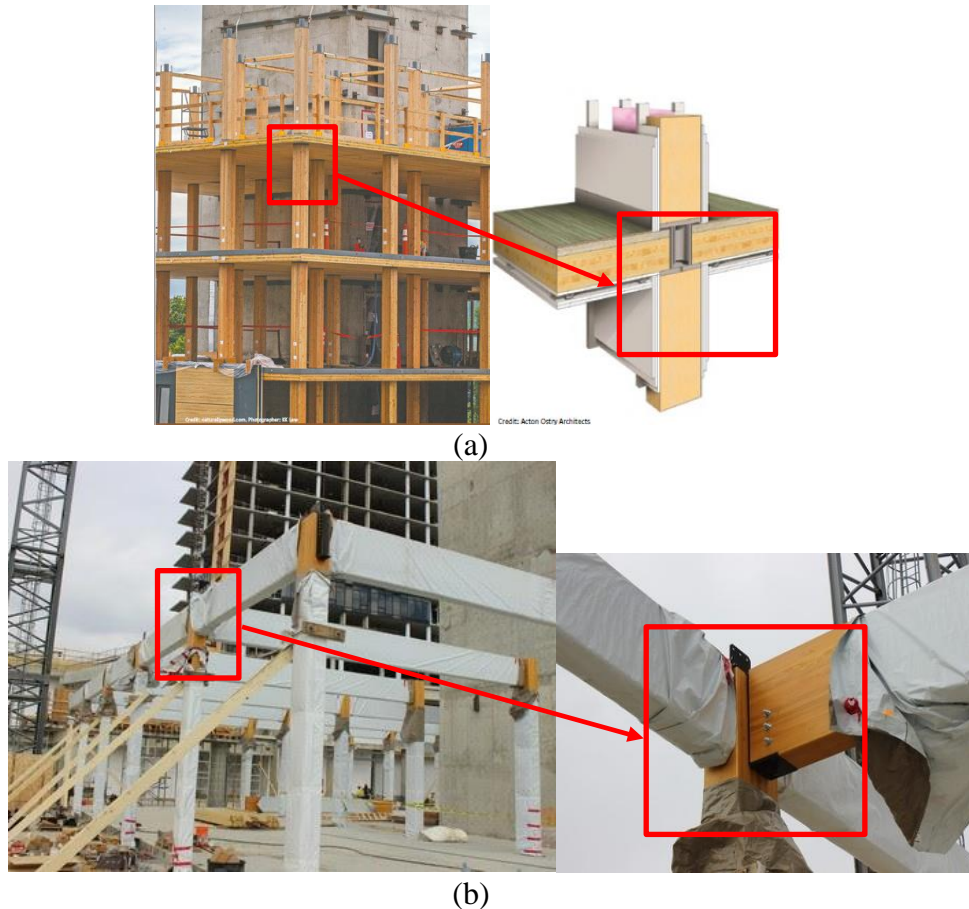
Figure 3. (a) Glulam column - CLT diaphragm VLRS and sample connection in the Brock Commons Building (Courtesy of FAST & EPP/Source: Woodworks & CWC) (b) the Glenora West Block 300 building and sample frame beam-column VLRS connection (Courtesy of Beam Craft: <https://www.beamcraft.ca/projects/project/westblock>)

In this section, ten recommendations are highlighted for practicing engineers to consider when designing mass timber structures to avoid disproportionate collapse scenarios. Although the recommendations are general and can be applied to all building with different VLRSs and LLRSs, they are mainly considered for two common structural types. Figure 2 (a) and (b) show two common VLRS and the associated connections used in the Brock Commons building and the Glenora West Block 300 located in Vancouver and Edmonton, respectively. Disproportionate collapse is considered an ultimate limit state; hence, it is expected that the mass timber components, whether they are glulam or CLT, behave mainly in an elastic manner and all the non-linear deformation happens at the location of the connections. As a result, connections are playing a very important role in the structural integrity of mass timber systems. The key connection in the Brock Commons building are the column-to-column connections made of hollow structural steel (HSS). For the Glenora building, the key connection is a monolithic U-shaped bent plate screwed to supported beams as well as the column above.

Below are ten recommendations to mitigate disproportionate collapse in mass timber buildings considering the structural systems shown in Figure 3:
